# NATIONAL TRANSPORTATION SAFETY BOARD

MATERIALS LABORATORY FACTUAL REPORT

Report No. 03-082

Place : Tillamook Inlet, Garibaldi, Oregon  
Date : June 14, 2003  
Vehicle : SPV Taki-Tooo  
NTSB No. : DCA03MM035  
Investigator : Rob Jones, MS-10

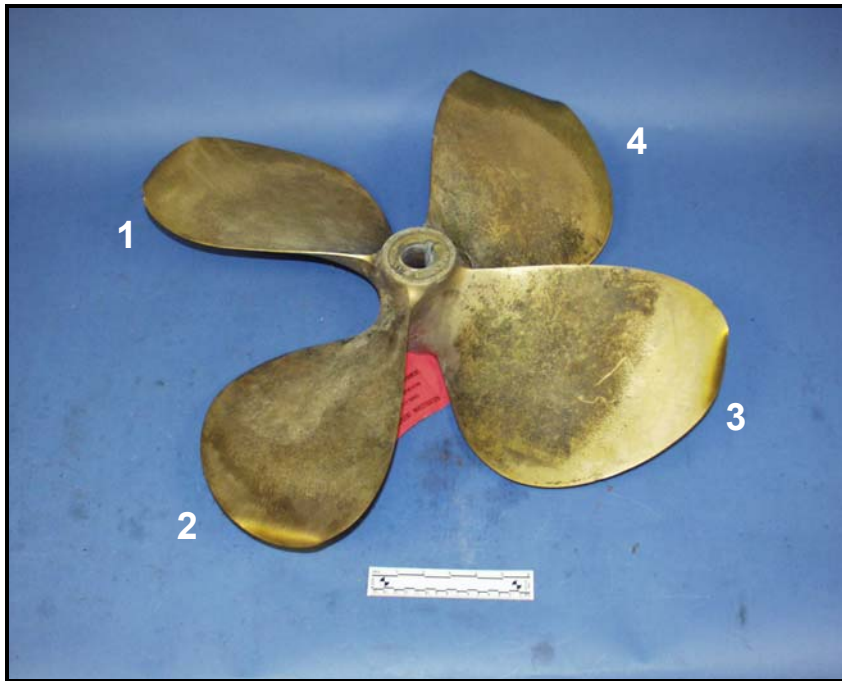
An overall view of the aft side of the propeller from the Taki-Tooo is shown in figure 1. The propeller was submitted to document any damage. For ease of reference, the propeller blades have been numbered "1" through "4" as shown in figure 1.

Additional damage was also noted on blade "1". Two areas of local deformation (approximately dime-sized) were noted on this blade, one approximately midway along the leading edge, and one on the trailing edge side of the curl. Forces acting on the forward side of the blade created these deformation areas, and the resulting deformation was in the aft direction. No evidence of impact from hard material was noted in these areas. The outer one third to one half of blade "1" was also bent in the aft direction, resulting in the tip being approximately 0.75 inch further aft than the tips of the other blades.

Figure 1. Overall view of the aft side of the propeller, with the blades labeled "1" through "4".

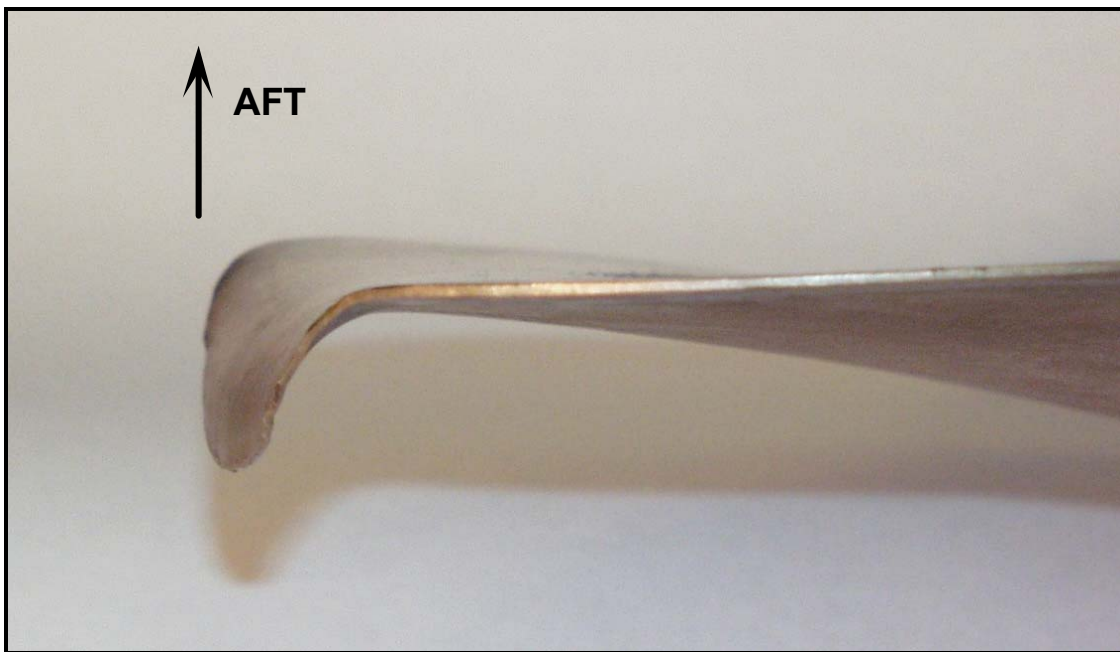
The tip of each blade was curled in the forward direction. The total angle of the curl and the area over which the curl occurred increased in the counter clockwise direction (aft looking forward) from blade "1" through blade "4", with damage over about  $\frac{3}{4}$  inch on blade "1" and over about 1.5 inches on blade "4" (see figure 2). The aft side of the blades did not contain any type of scoring marks or scraping damage associated with the curls. The curl damage was consistent with contact of the propeller with a soft bottom while under power.

Figure 2. View of the curl damage on blade "4".
